Attachment 2

Attachment 3
Photograph Log

Photograph Log for EPA's December 3, 2010 Electrochem Solutions RCRA and CWA Inspection

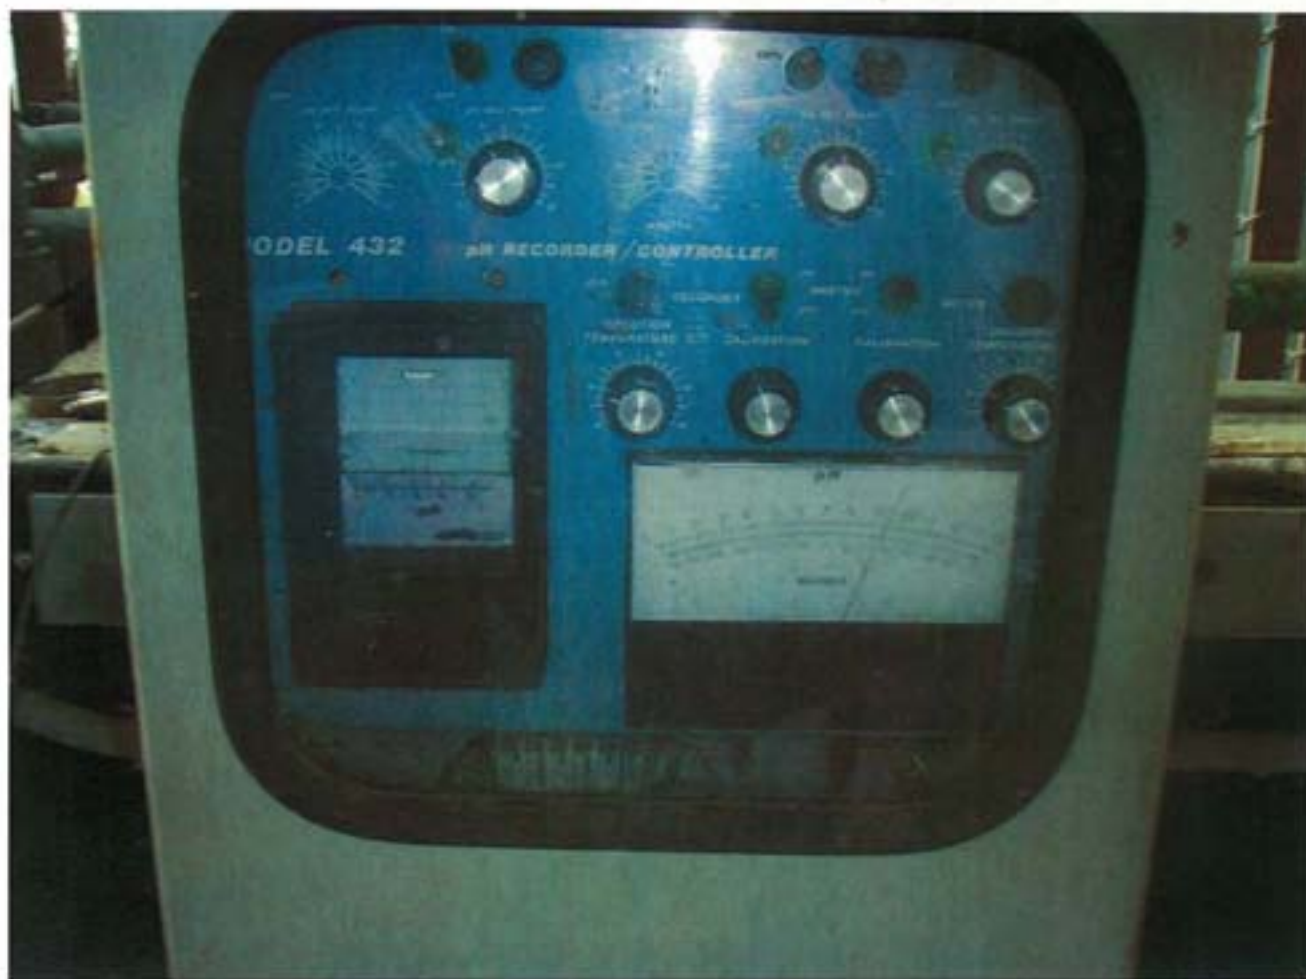
PC030071

- 071. Water Treatment and Equipment Area: Close up of pH meter. Note: the pH meter is not functioning.
- 072. Less than 90-day Hazardous Waste Accumulation Area (Waste Chemical Storage): Areas is lined. There are approximately thirty 55-gallon containers and approximately two 5-gallon containers in the photograph. Containers along the short wall are open and labeled as "filters" and "liners." The floor in this area is stained, but lined. Many labels on the containers could not be read. One container label in view reads "nickel strip" and another states "gold alodine."

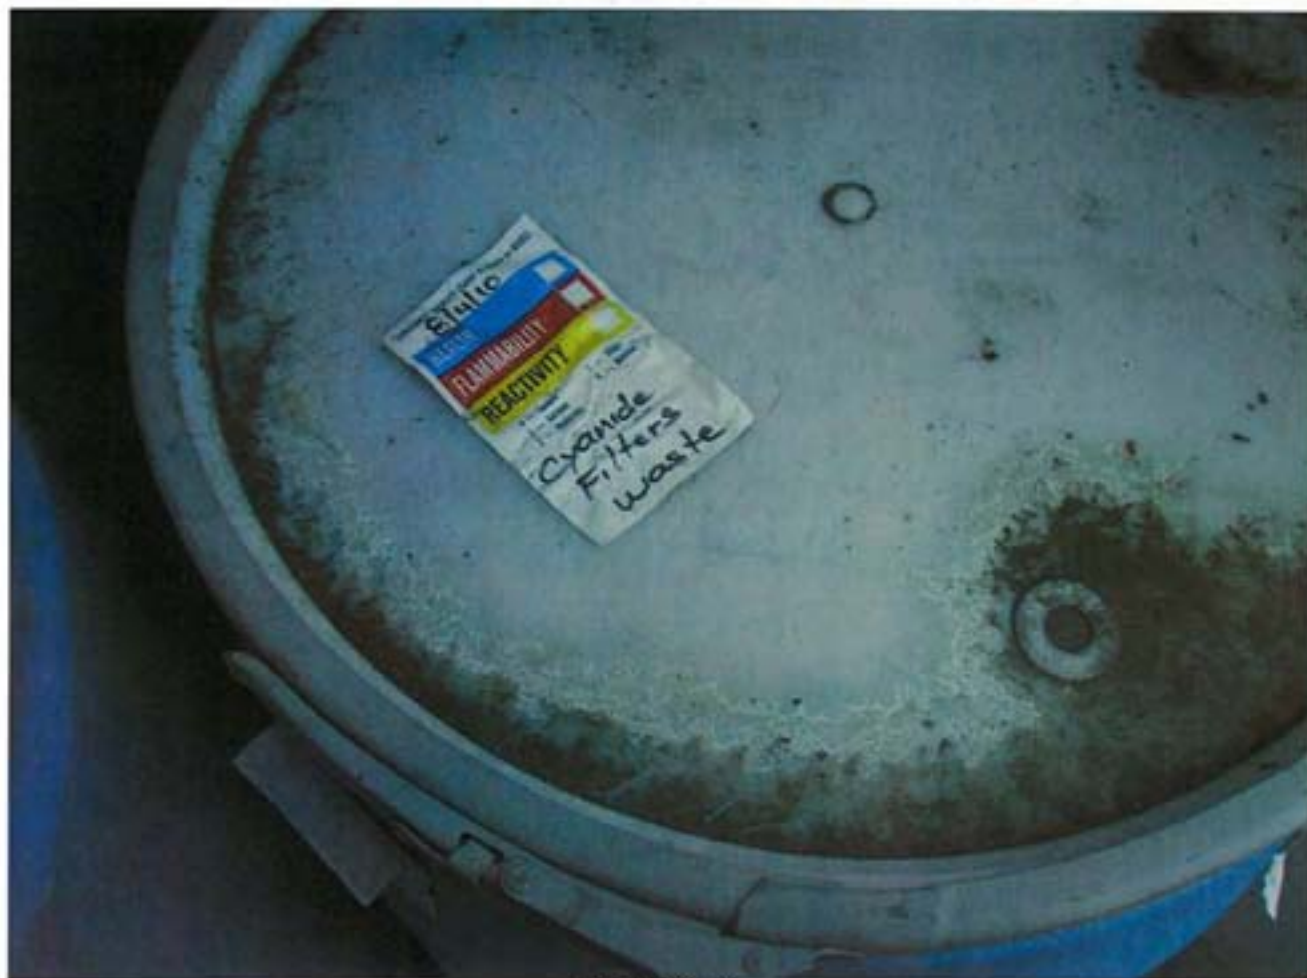
PC030078

- 077. Less than 90-day Hazardous Waste Accumulation Area (Waste Chemical Storage): Slot drain is full of liquid.
- 078. Less than 90-day Hazardous Waste Accumulation Area (Waste Chemical Storage): One of three 55-gallon container of cyanide waste filter label has an accumulation start date of 8/4/10.

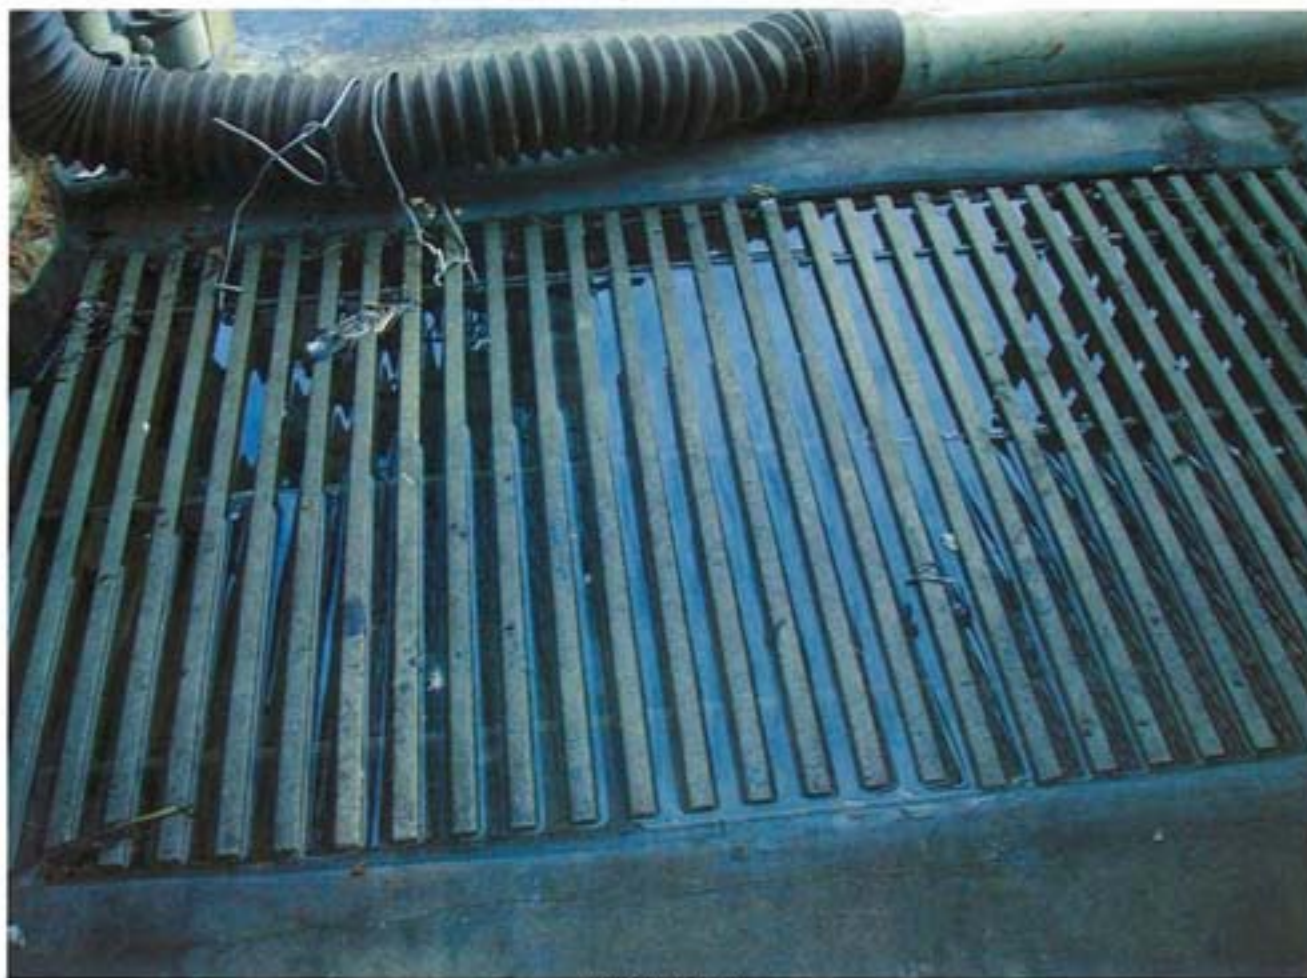
PC030079

- 079. Less than 90-day Hazardous Waste Accumulation Area (Waste Chemical Storage): Another view of slot drain seen in photograph 077 full of liquid.
- 080. Less than 90-day Hazardous Waste Accumulation Area (Waste Chemical Storage): View of storm drain from the slot drain at the hazardous waste storage area.

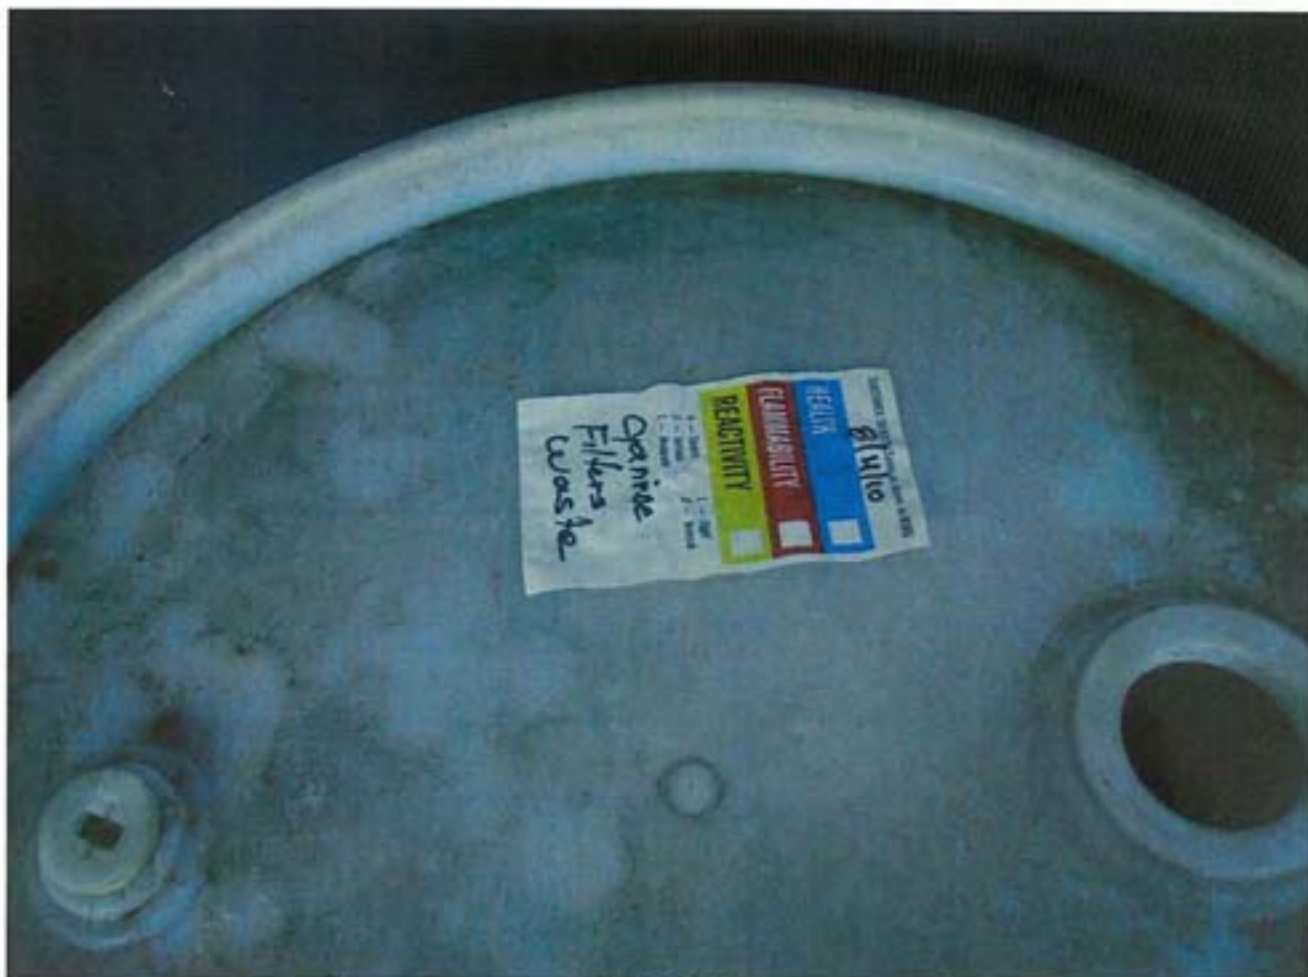
PC030082

- 082. Less than 90-day Hazardous Waste Accumulation Area (Waste Chemical Storage): One of three 55-gallon container of cyanide waste filter label has an accumulation start date of 8/4/10. Note: the bung on the container is open.

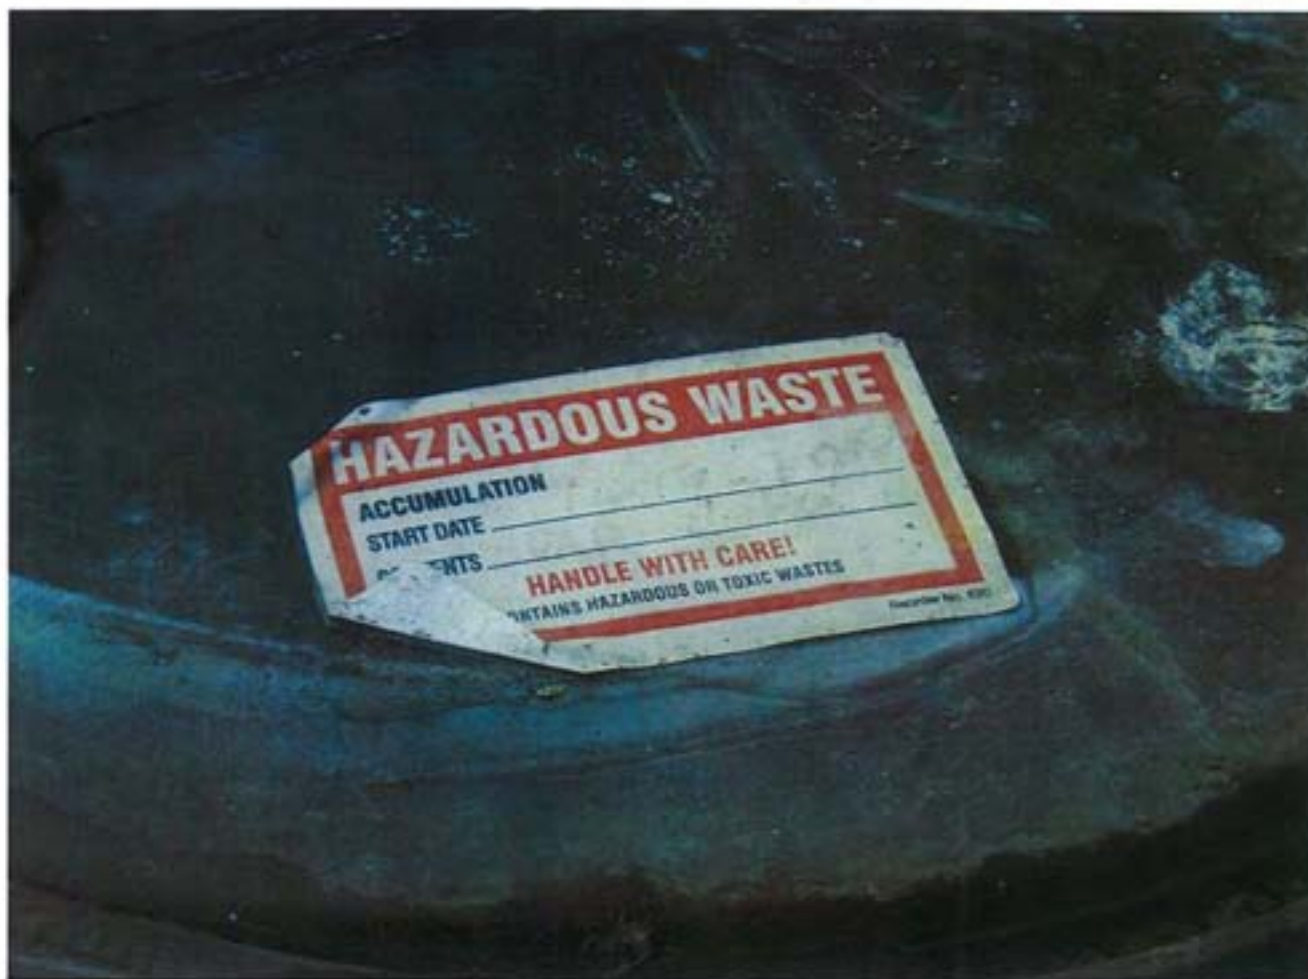
PC030084

- 084. Less than 90-day Hazardous Waste Accumulation Area (Waste Chemical Storage): A label seen on one of the 55-gallon containers is faded and appears to have an accumulation start date of 1/19/09. Note: container is corroded (*photograph taken by John Schofield*).

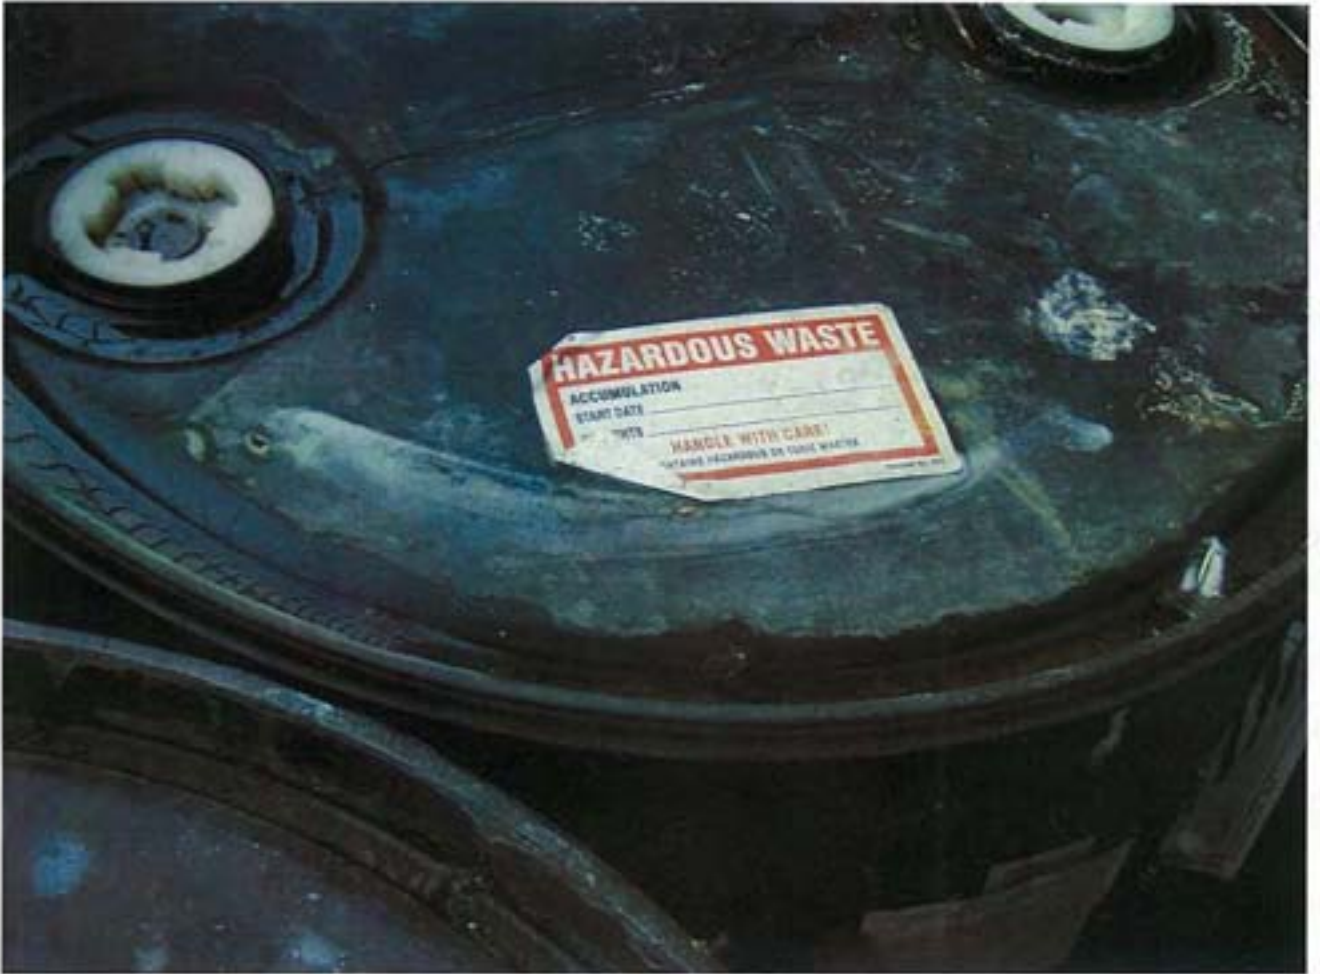
PC030089

089. Less than 90-day Hazardous Waste Accumulation Area (Waste Chemical Storage): Same 55-gallon container in photograph 084. Note that the container has liquid on top and is corroded (*photograph taken by John Schofield*).

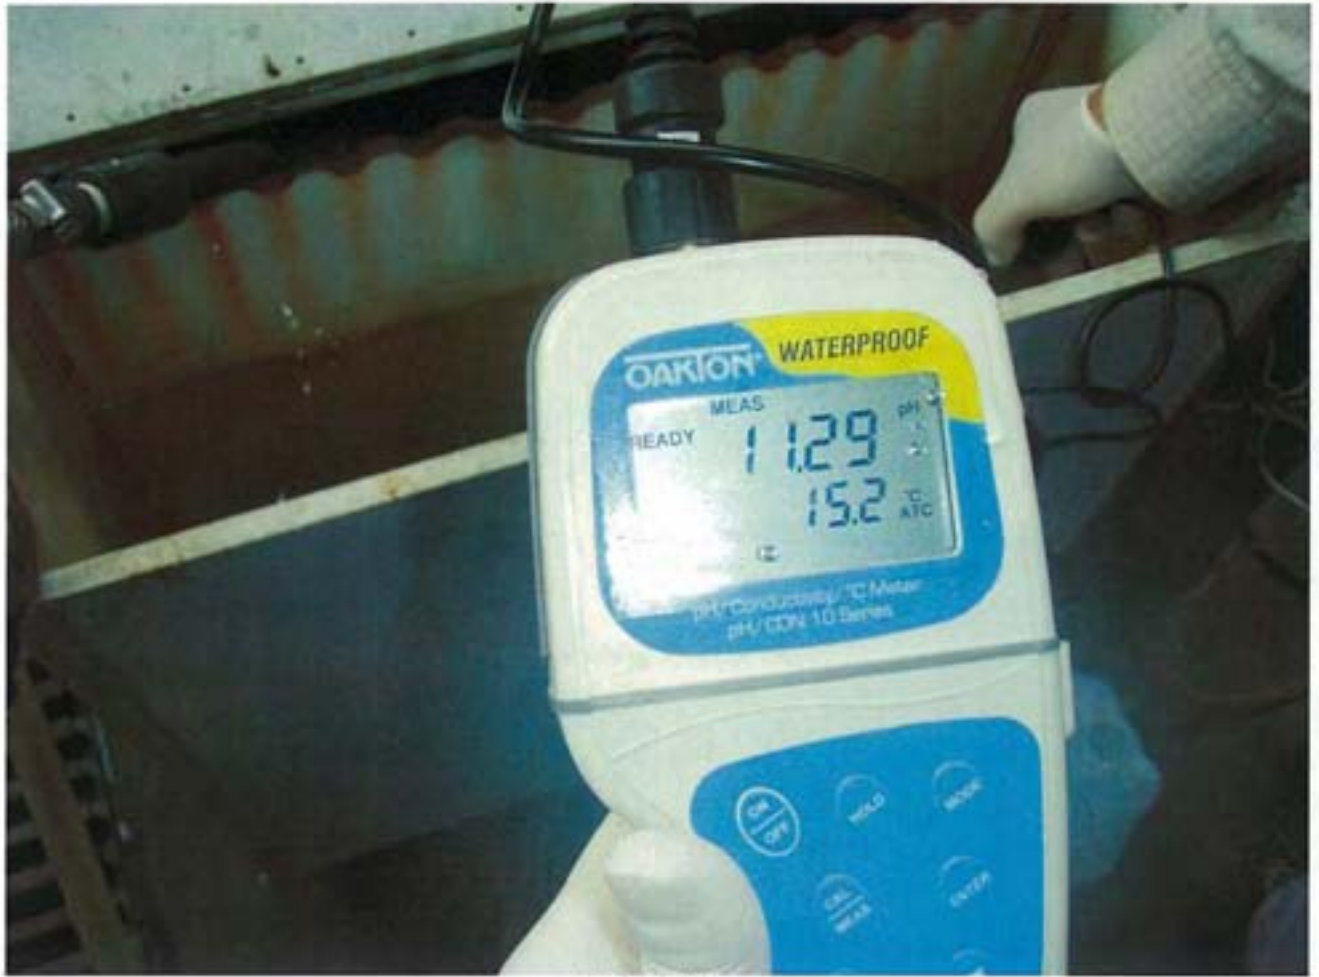
PC030115

115. John Schofield monitoring pH levels in sewer sample box located in the Water Treatment and Equipment Area (*photograph taken by Chris Boykin*).
